Stop Use & Inspect Notice

**Dyna-Lock[®] Self-Retracting Lanyard - 10m (30ft) and 16m (50 ft) Types and
Dynevac[®], Dynevac II, and Lynx[®] Rescuers - 16m (50ft) Types
Manufactured between June 1, 2004 and September 30, 2004**

Stop Use & Return Notice

**Aptura LT30 Self-Retracting Lanyards
Manufactured from March 1, 2004 through November 19, 2004**

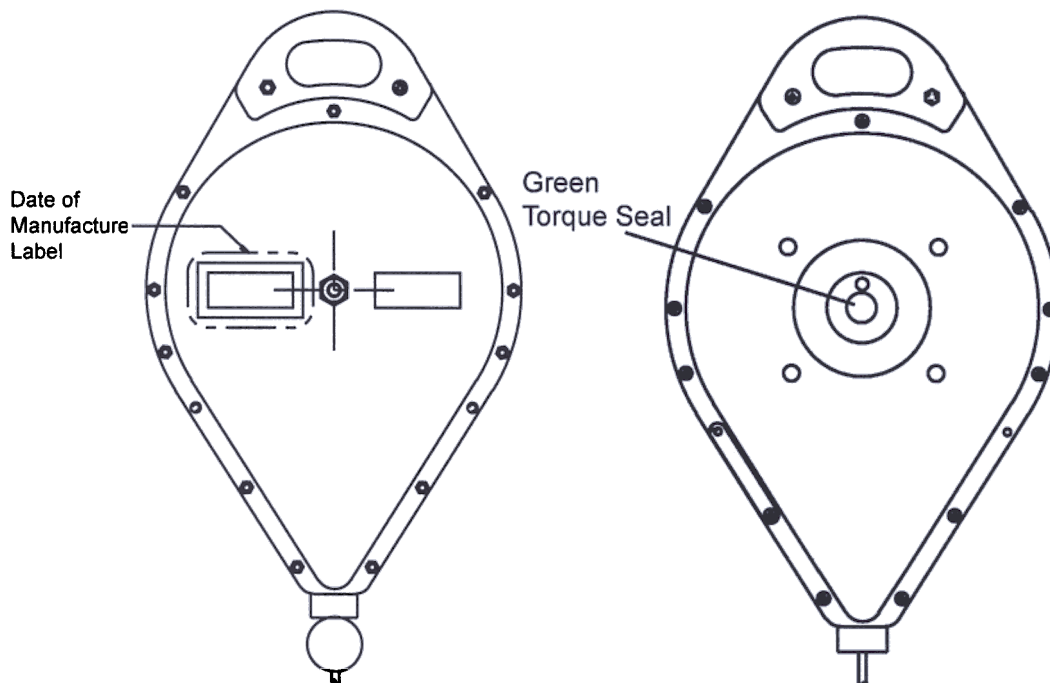
Inspect all products to determine the date of manufacture. The date of manufacture is located on the label affixed to back of the housing (see diagram below). If this date is within **June 1, 2004 and September 30, 2004** or if the date cannot be determined, the product is subject to this notice and must be inspected.

2. If the unit has green torque seal in the center of the torque nut, then it has already been inspected. The green torque seal is located in the center of the face of the housing. If green torque seal is present, the unit is not subject to this notice.

1. **Self Inspection:** Contact Customer Service and request an inspection kit that will allow you to inspect your unit in the field to see if this condition is present. Customers in Canada should call 1-888-396-1067. Customers in the United States or Mexico should call 303-975-2314. The kit will include a special tool to check the unit, along with detailed instructions on how to perform the inspection, complete with a video CD demonstration. If your unit is found to exhibit this condition, then you can contact Customer Service for instructions on returning the product to your nearest authorized service center or the MSA Englewood facility for repair. If your unit does not exhibit this condition then you will be instructed to remove the orange torque seal and replace it with green torque seal, provided with the kit. The unit can then be returned to service.

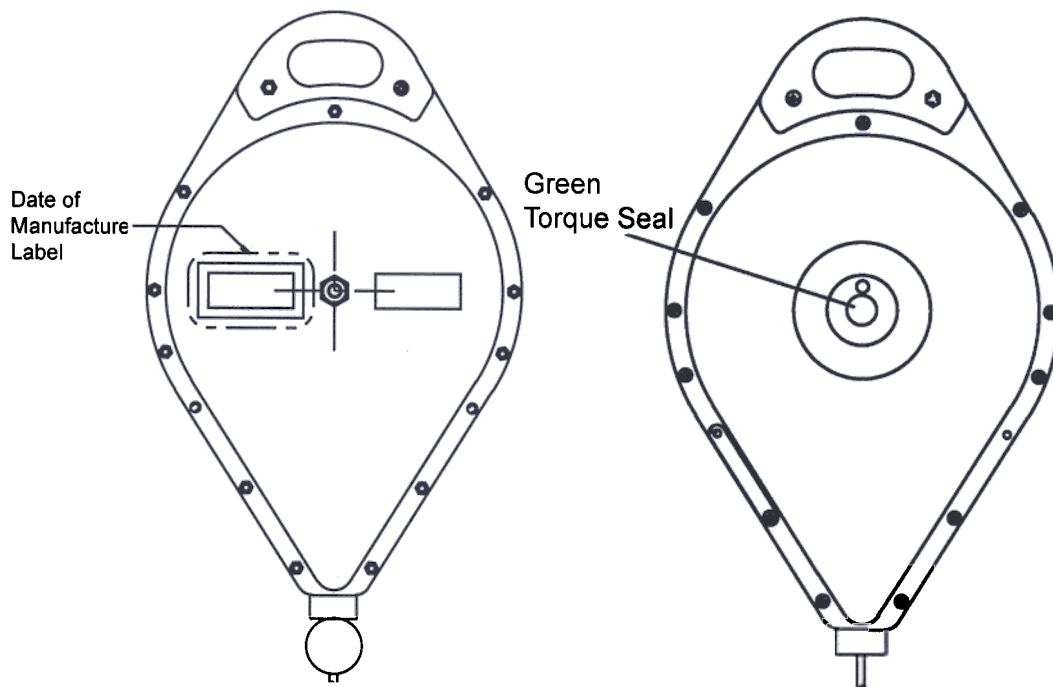
Inspect all products to determine the date of manufacture and if green torque seal is present. The date of manufacture is located on the label affixed to back of the housing and the green torque seal is located in the center of the face of the housing. (see diagram below). If the date of manufacture is within the affected range or if the date cannot be determined, the product is subject to this notice and must be removed from service, with the following exception. If green torque seal is present, the unit is not subject to this notice, even on units with a date of manufacture within the affected range.

The returned product will be inspected for this condition and repaired as needed. We will use a green torque seal on the torque nut located in the center of the face of the housing and enter a new date under the "last factory service" field on the label shown above. The original or replacement products will be express shipped to you within four working days of our receipt of your product.

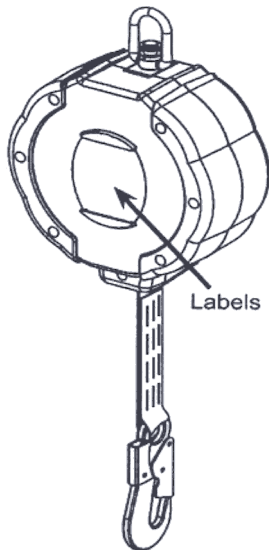
**APTURA LT30 SRL
(back view)**

If MSA logo only is present
and print is red, the unit is not
affected by this advisory.

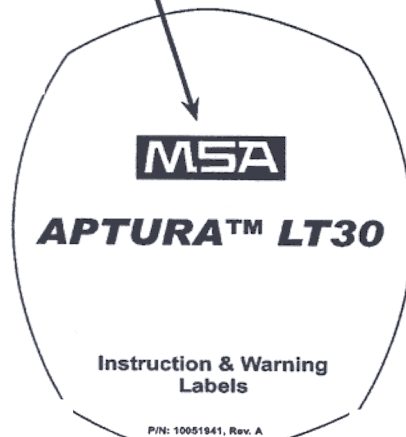
**APTURA LT30 SRL
Cover Label**

Inspect all products to determine the date of manufacture. The date of manufacture is located on the label affixed to back of the housing, underneath the label cover (see diagram below). If the date of manufacture is within the affected range or if the date cannot be determined, the product is subject to this notice and must be removed from service, with the following exception: If a label cover bearing the MSA name (MSA name only, not MSA

FP) in red print is present, the unit is not subject to this notice, even on units with a date of manufacture within the affected range.

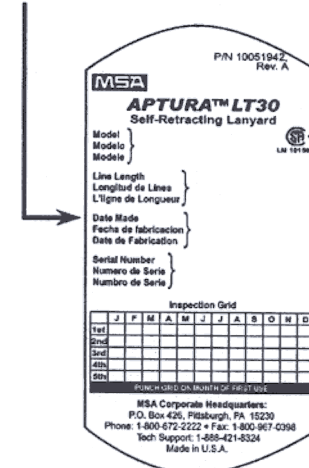
**APTURA LT30 SRL
Data Card
(found under Cover Label)**

Date of Manufacture
